Funderingar kring broraset i Minneapolis

Peter Collin

Professor samverkanskonstruktioner, LTU
Ansvarig Teknikområde Bro, Ramböll Sverige

Minnesota I-35 Bridge över Mississippi River

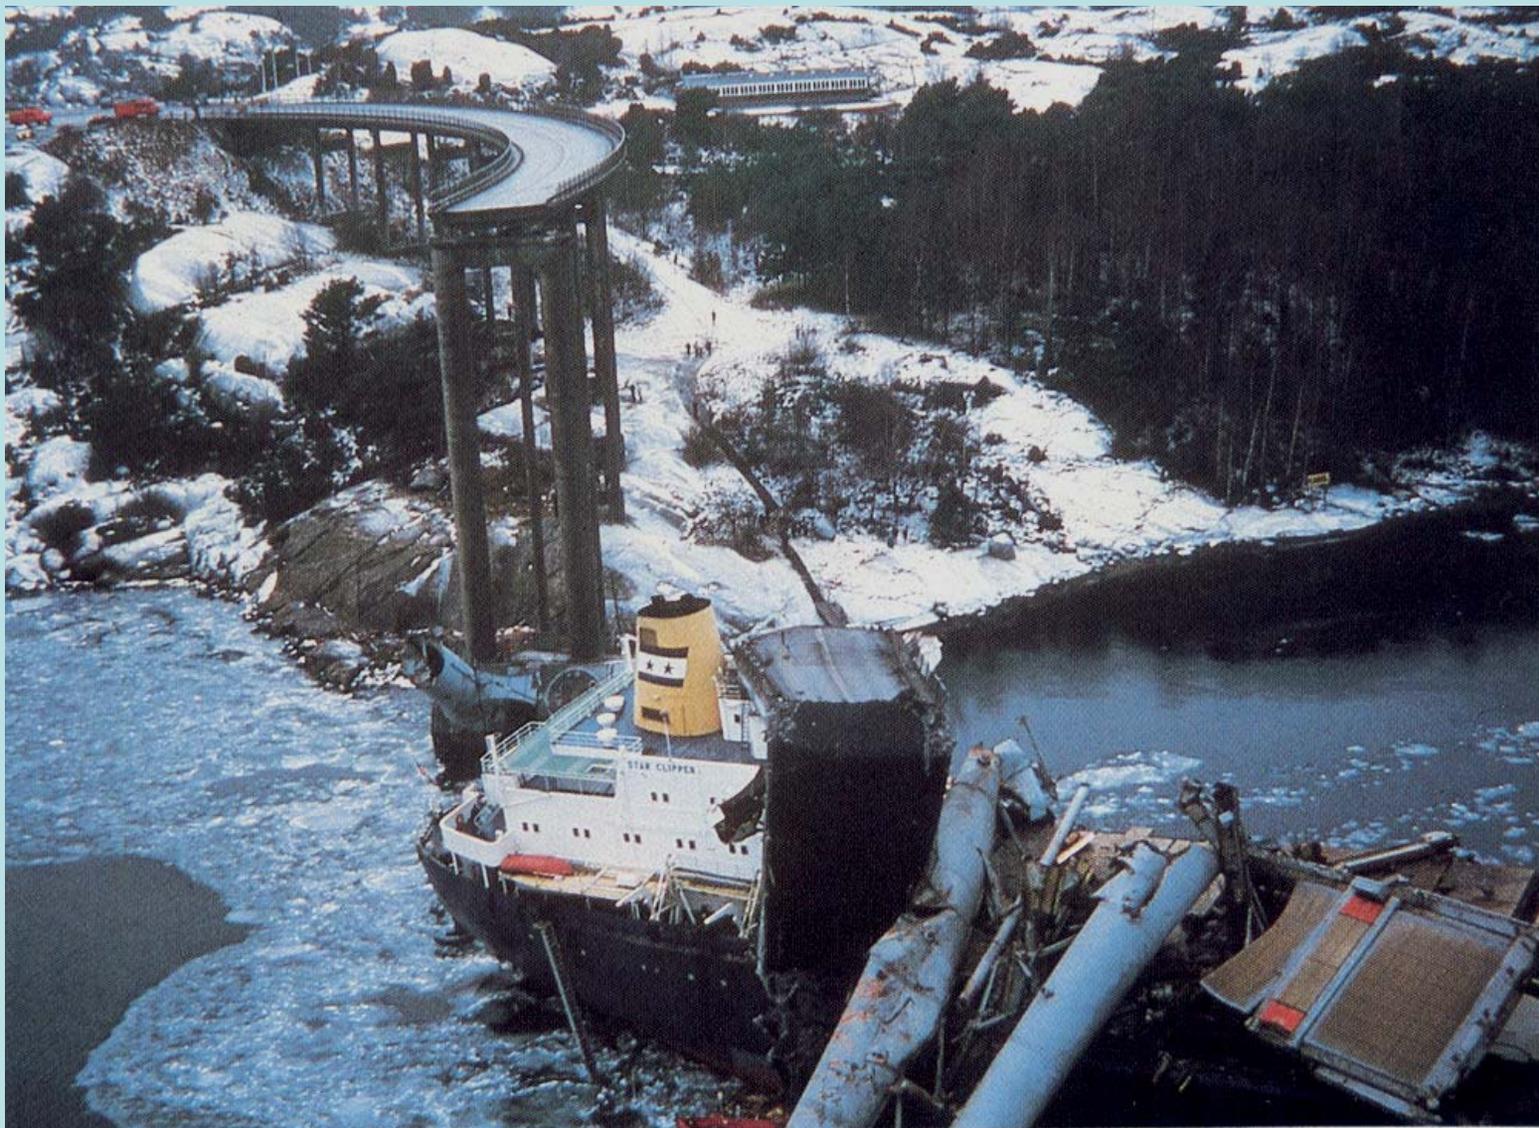
Tjörnbron, 1980. 8 människor dog efter påsegling av brons underliggande båge. Alternativ är att ha anfangen en bit upp på land eller ledverk.

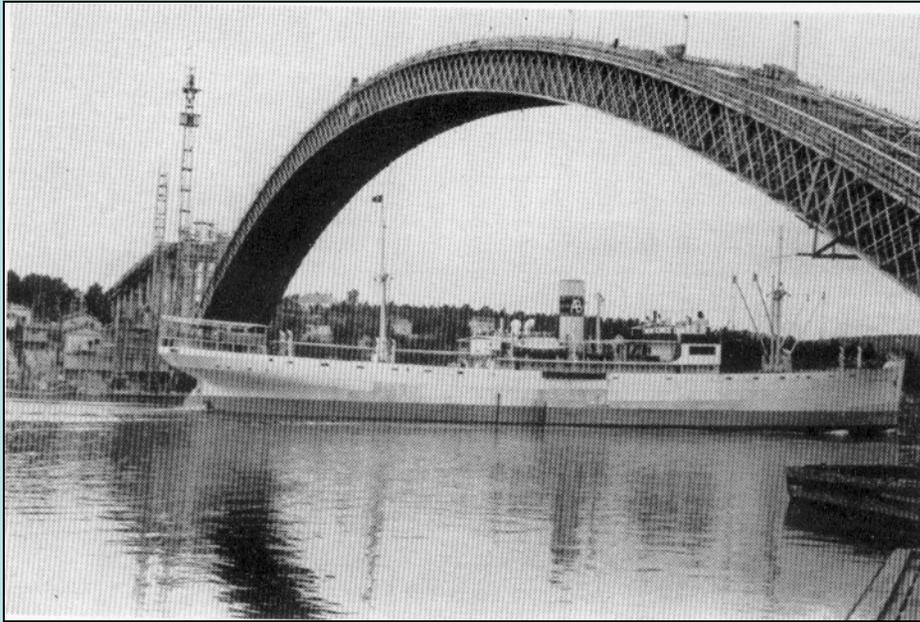
Sandöbron, rekordlångt bågspann i trä rasade 31 augusti 1939. 18 byggnadsarbetare omkom.

Till bygget av formen hade använts 2x8 tum plankor på högkant som spikades ihop med 60 ton 10 tums spik, formen för bågen vägde 1000 ton.

Efter detta byggdes bron upp igen, med den skillnaden att denna gång pålades i älvbotten för att bära upp gjutformen för bågen, och Sverige fick ett rekordlång bågspann i betong, 269 meter.

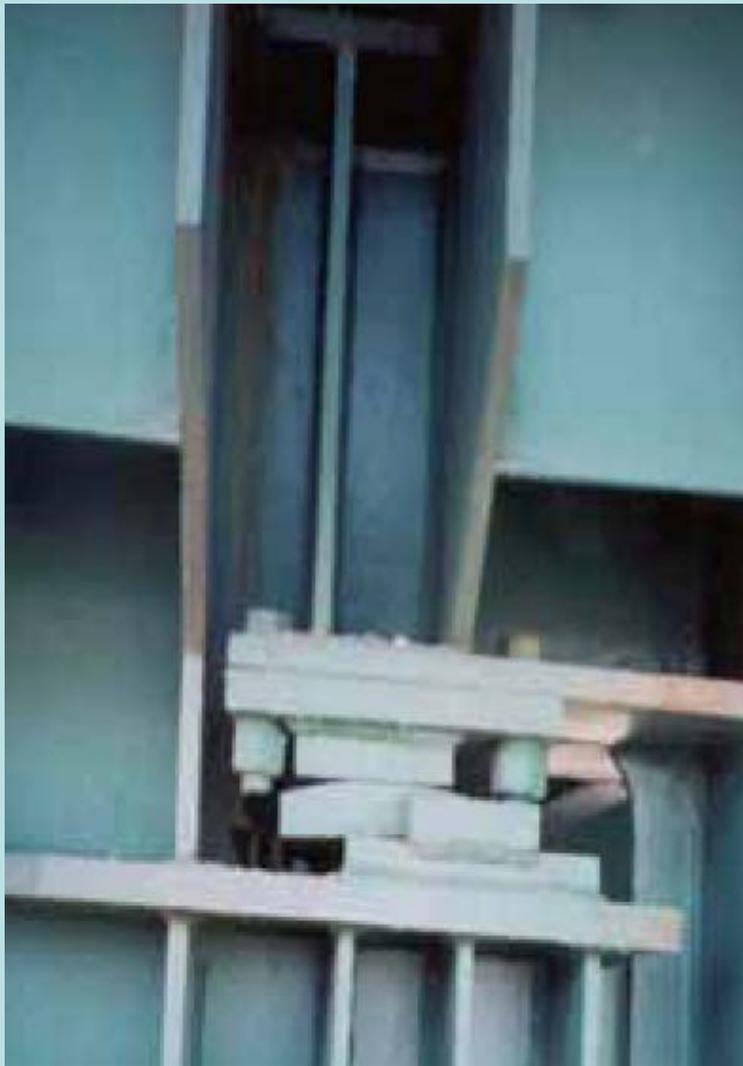
on hinge area. Additionally, the tops of the beam ends are contacting at the top flange or at the web along this joint. [94/2005] All hinge assemblies are expanded beyond tolerance; sliding plates extend 4" or more beyond the base plates, reducing bearing capacity. At beam #10, the sliding plate has tipped, falling off the base plate, and is preventing the joint from opening. [2005] Hinges should be flushed.

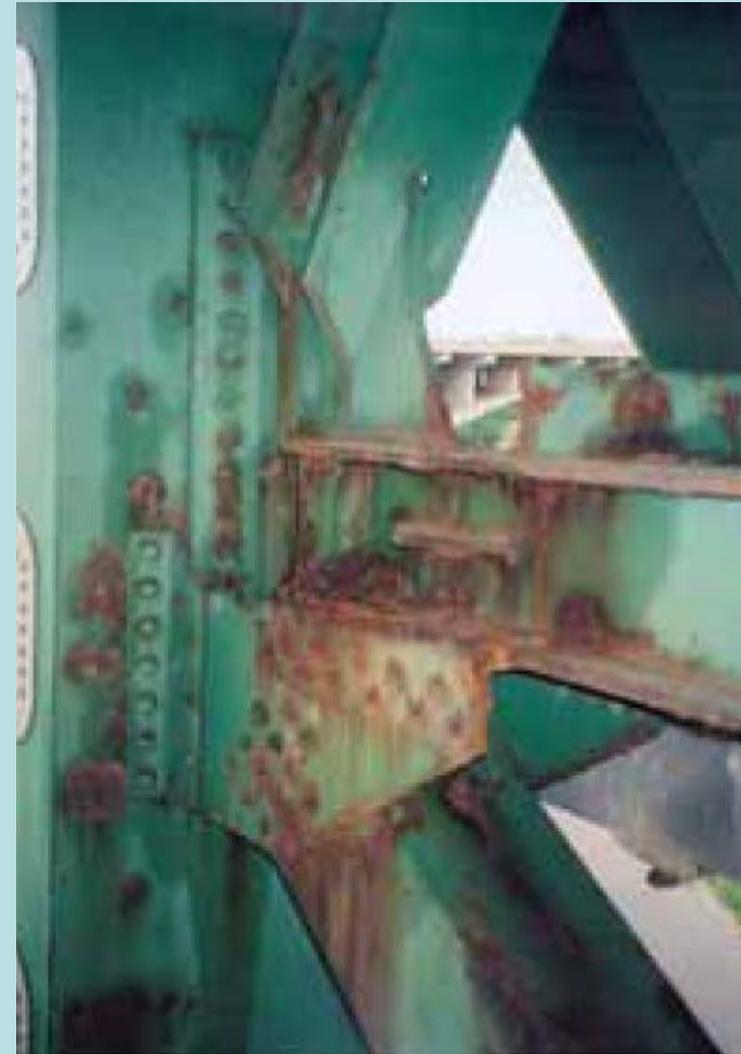
Stringer #2 (south side): bearing block has rotated 90°.

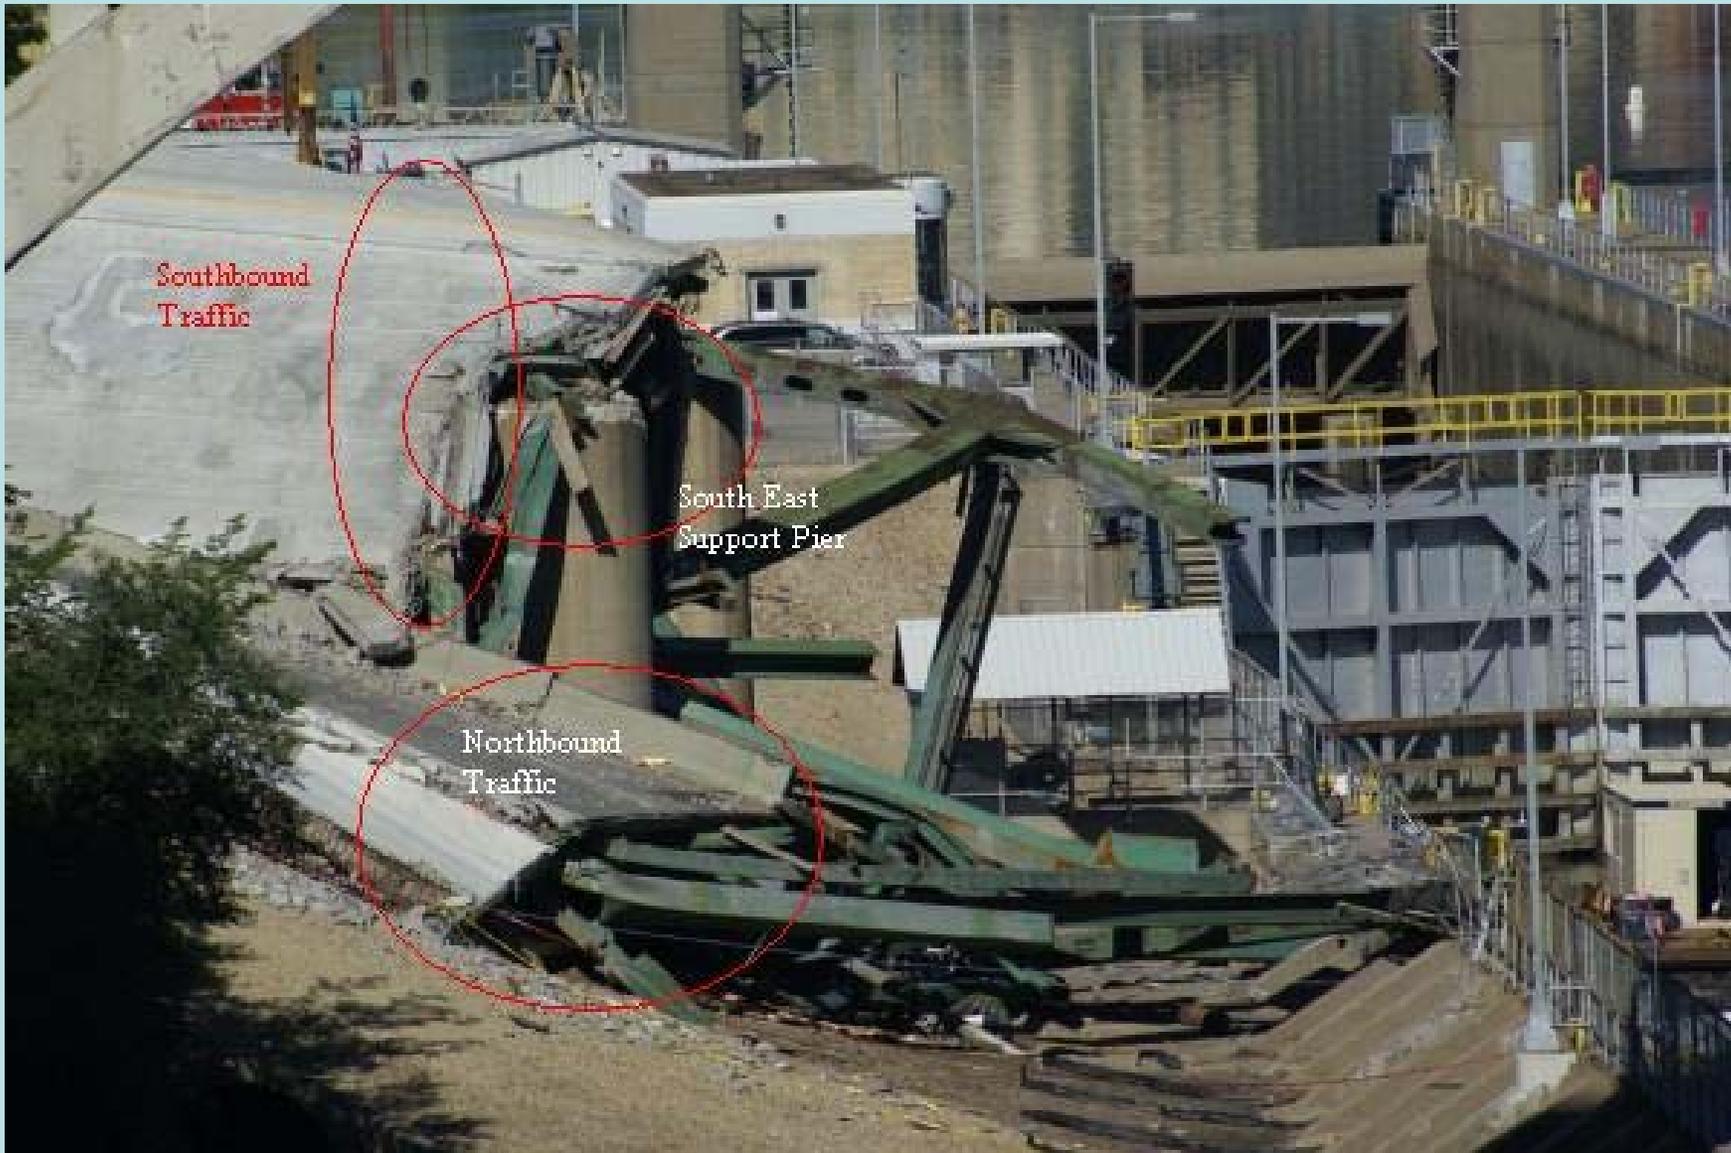
The situation before the crash is that the south end bearings were frozen. Post collapse views show that the bearing have not been moving. These bearing are in place to allow the entire bridge to move as it expands and contracts during heating and cooling cycles. With the bearing inoperative, the bridge would have to flex and bend. To aggravate the situation, the Twin Cities area had been experiencing a spell of unusually hot weather, with the temperature being 91 degrees at the time of the collapse.

A second unusual factor is that the bridge was undergoing repair work on the deck. The normal 8 lanes were reduced to 2 lanes each direction, with two lanes each direction being closed for repair work. The northbound lanes had a large pile of gravel placed right above the U-9 and U-10 connector joints.

The third leg of the disaster concerns the gusset plates that held the beams together at the connector joints. These plates vary from one-half inch to one inch in thickness. There is speculation that the one-half inch plates may have been too thin to support the weight of the bridge, a design flaw that may have been an accident waiting to happen. In addition, recent inspections have found that rust was attacking these gusset plates. The L-11 gusset plate had lost one-half of its thickness in places due to rust. To aggravate this situation, anti-ice solution and salt may have collected in this area speeding up the corrosion, and bird droppings may have accumulated in this area making inspections all the more difficult.

The Minneapolis Star Tribune reports that connectors L-9, U-10, and L-11 all show evidence of pre-collapse damage. The failure of any one of these gusset plates would start a chain reaction of failures that would lead to the collapse of the bridge.
