# Structural Safety, Experiences from Finland

Teppo LEHTINEN

Ministry of The Environment

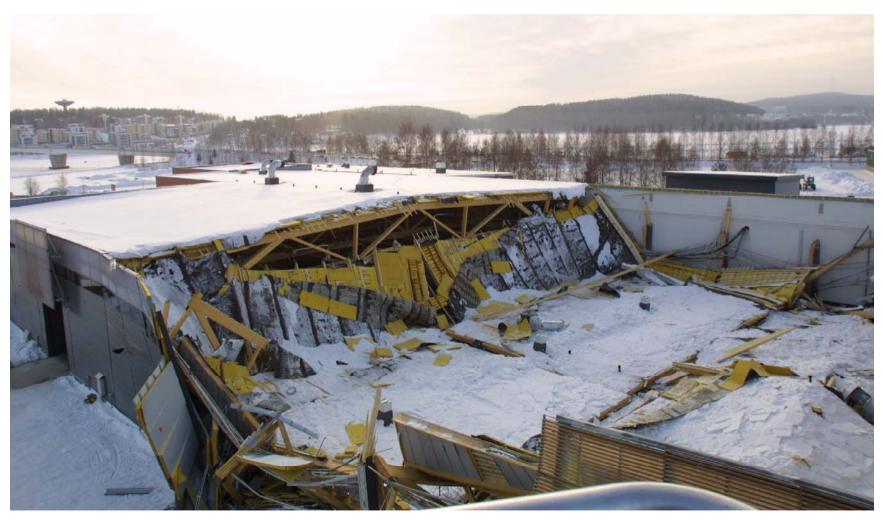
2000 m² roof collapse of fair centre in Jyväskylä 2003

trusses made of laminated timber, span lenght 55 meters

strength of the biggest joints featured ~50% of the planned rates

roof truss pair having first collapsed, only had 7 dowels of 33

major dowel joints yielded in a cleavage fracture, that is, the joint section had torn off the timber along the outer rows of the dowel group.

European planning instructions failed to consider such a type of breaking

- Finland informed comission and TC250 June 2003 with detailed technical report
- CEN/TC250 gave letter of warning concerning application on ENV 1995-1-1 (block shear failure) November 2005 (7232:CEN/TC 250)
- Defect concerning the use of ENV version of EC5 was remedied by giving a national decree (of NAD)
- Beside the fair centre in Jyväskylä there was an another remarkable large multi-purpose hall in Joensuu, which structures were strengtened due to the information of block shear failure possibility

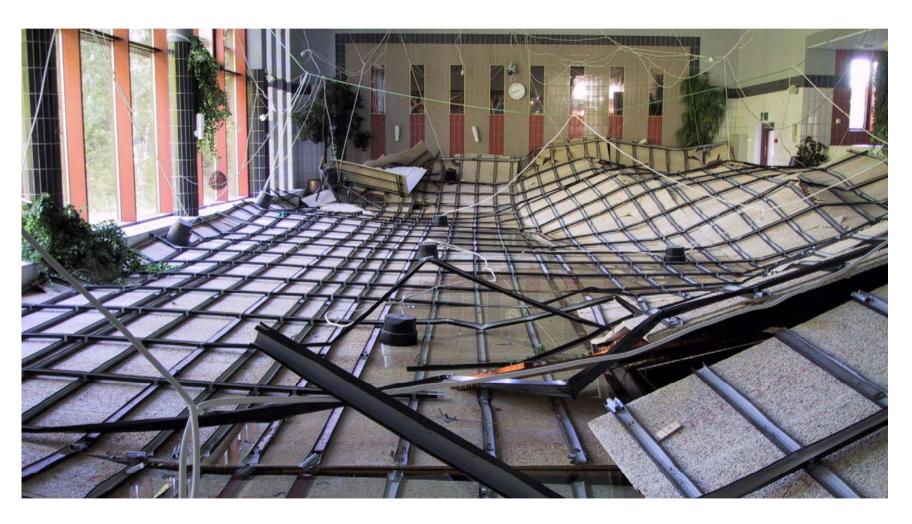
Collapse of swimming hall inner roof structure in Kuopio 2003

entire ceiling of the main pool 256 m² was dropped

collapse was caused by a breaking of the suspension wires made of stainless steel, as a result of stress corrosion

Builders had no knowledge of SFS-ENV 1993-1-4 + NAD and they were hence unable to use it in the selection of an appropriate steel quality for indoor swimming-pool and spa conditions.

- Ministry informed by a letter the building supervision authorities in communities of the spa conditions and of the use of stainless steel in those conditions
- Also the letter gave warning of the risks when the ceiling has been built as entirely integral without any expansion joints or special joints that would prevent a progression of the collapse

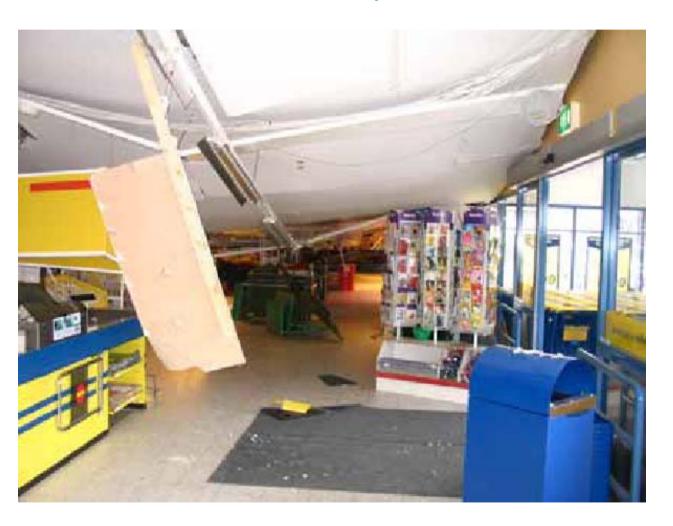
Collapse of super-market inner roof structure in Sysmä 2005

- one part of ceiling 400 m² was dropped
- cause was that the nail joints to the roof trusses were not strong enough

joints had mostly two nails nailed with a compressed air nail gun

nail joint details were not designed

loads were not evaluated and the load capacity of this type of joint was not ensured.

drawings did not indicate how the joint should be made.

- Common structure and common situation concerning design and construction
- Ministry informed by a letter the building supervision authorities of the case and of the withdrawal strenght of axially loaded nails also national standard body
- It was observed by a research, that when the connection dries after nailing, the withdrawal strength decreases considerably in Finnish climate conditions
- withdrawal strength of plain shank nails was only 43 % of the strength based on EN 1382 of connections
- The matter was included to CEN/TC250 letter of warning

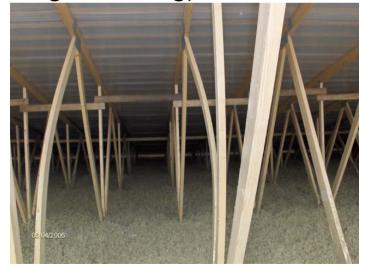
Entire roof structure 600 m² was collapsed

Supporting of wooden trussels in focus
 (breeing buckling)

(bracing, buckling)

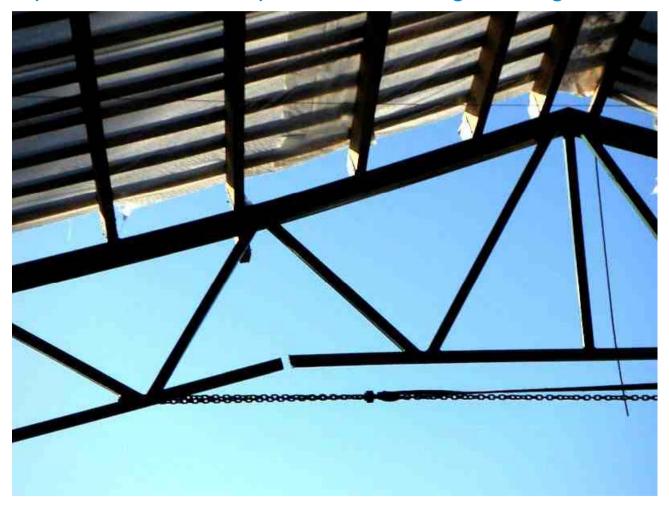
Several problems and collapses with farming buildings
