Funderingar kring broraset i Minneapolis

Peter Collin

Professor samverkanskonstruktioner, LTU
Ansvarig Teknikområde Bro, Ramböll Sverige

Minnesota I-35 Bridge över Mississippi River

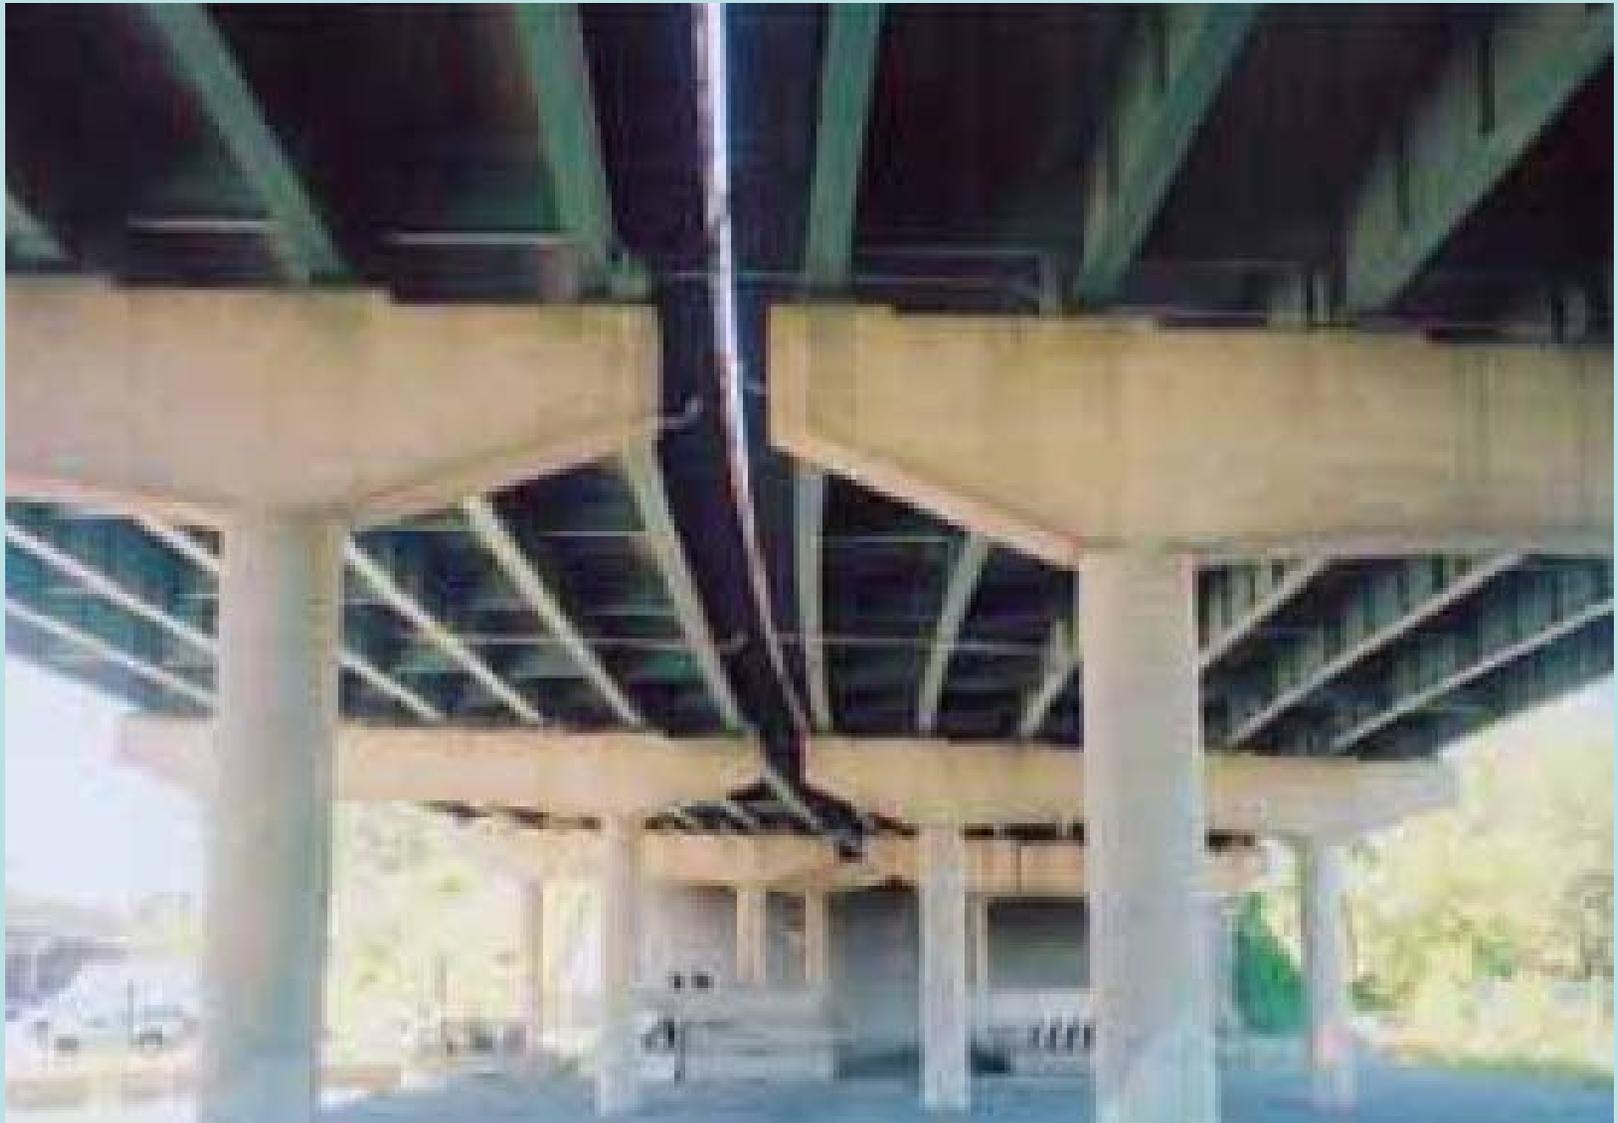
- Fatigue cracks at girder #1C (NBL), crack at the diaphragm bottom cutout, NE side measures 2" ("front face") and NW side measures 2-1/2" ("back face"). Fatigue cracks a girder #3 (NBL), crack at the diaphragm bottom cutout, measures 1-1/2" (both sides). The cracks are located in negative moment regions where the diaphragm web stiffener was not welded to the top flange and were previous fatigue cracks occurred and were repaired in 1998 and 1999. These areas should be inspected next year for any lengthening of the cracks and drilling of possible stress relief holes.
- The hinge joint in span #2 is locked in full expansion several beam-ends are contacting, and the hinge bearings are "frozen" and no longer functioning. Consequently, pier #1 has tipped slightly to the north, and the south abutment bearings are in full contraction. This area should be thoroughly inspected.

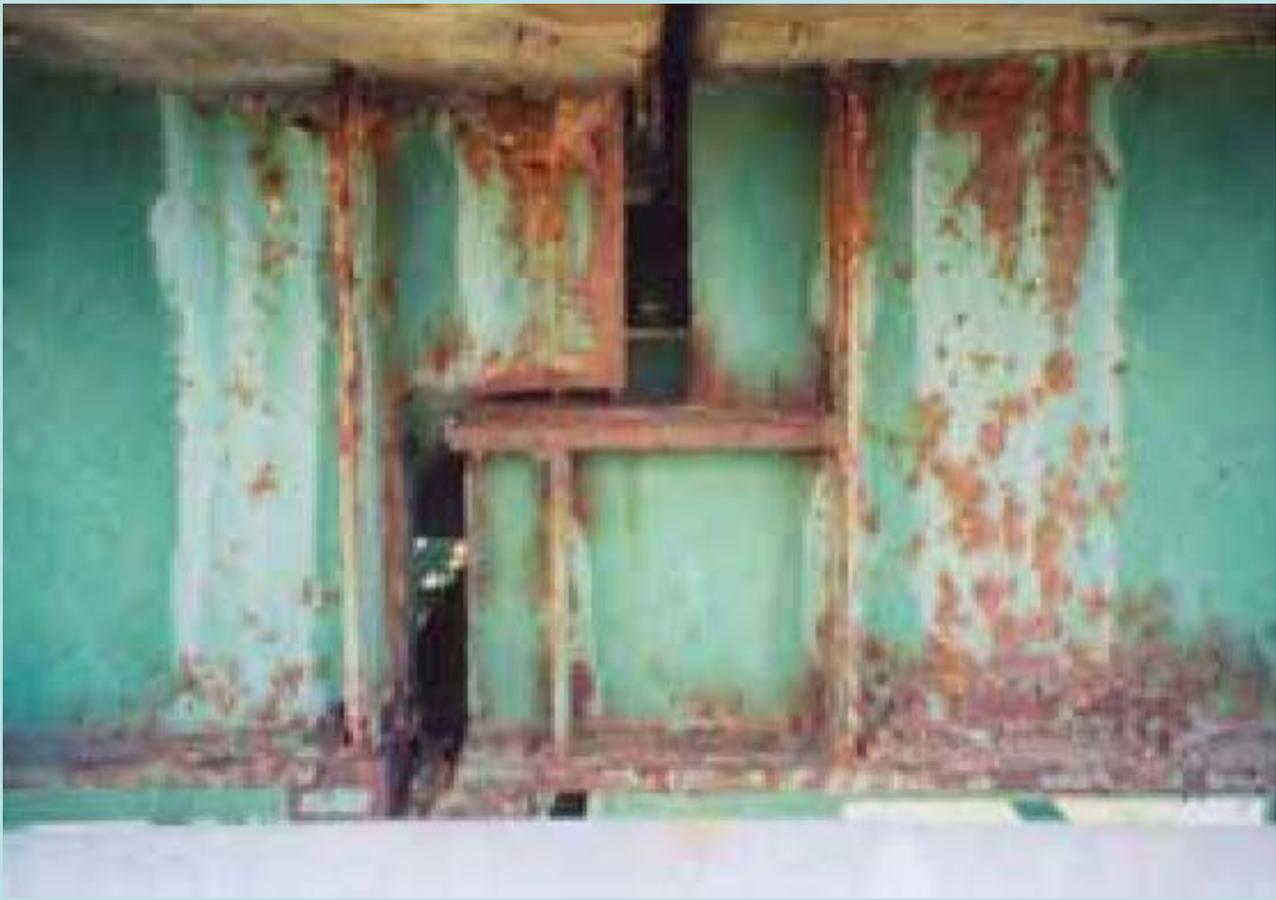
Sliding Plate @ Beam 5 NBL

on hinge area. Additionally, the tops of the beam ends are contacting at the top flange or at the web along this joint. [94/2005] All hinge assemblies are expanded beyond tolerance; sliding plates extend 4" or more beyond the base plates, reducing bearing capacity. At beam #10, the sliding plate has tipped, falling off the base plate, and is preventing the joint from opening. [2005] Hinges should be flushed.

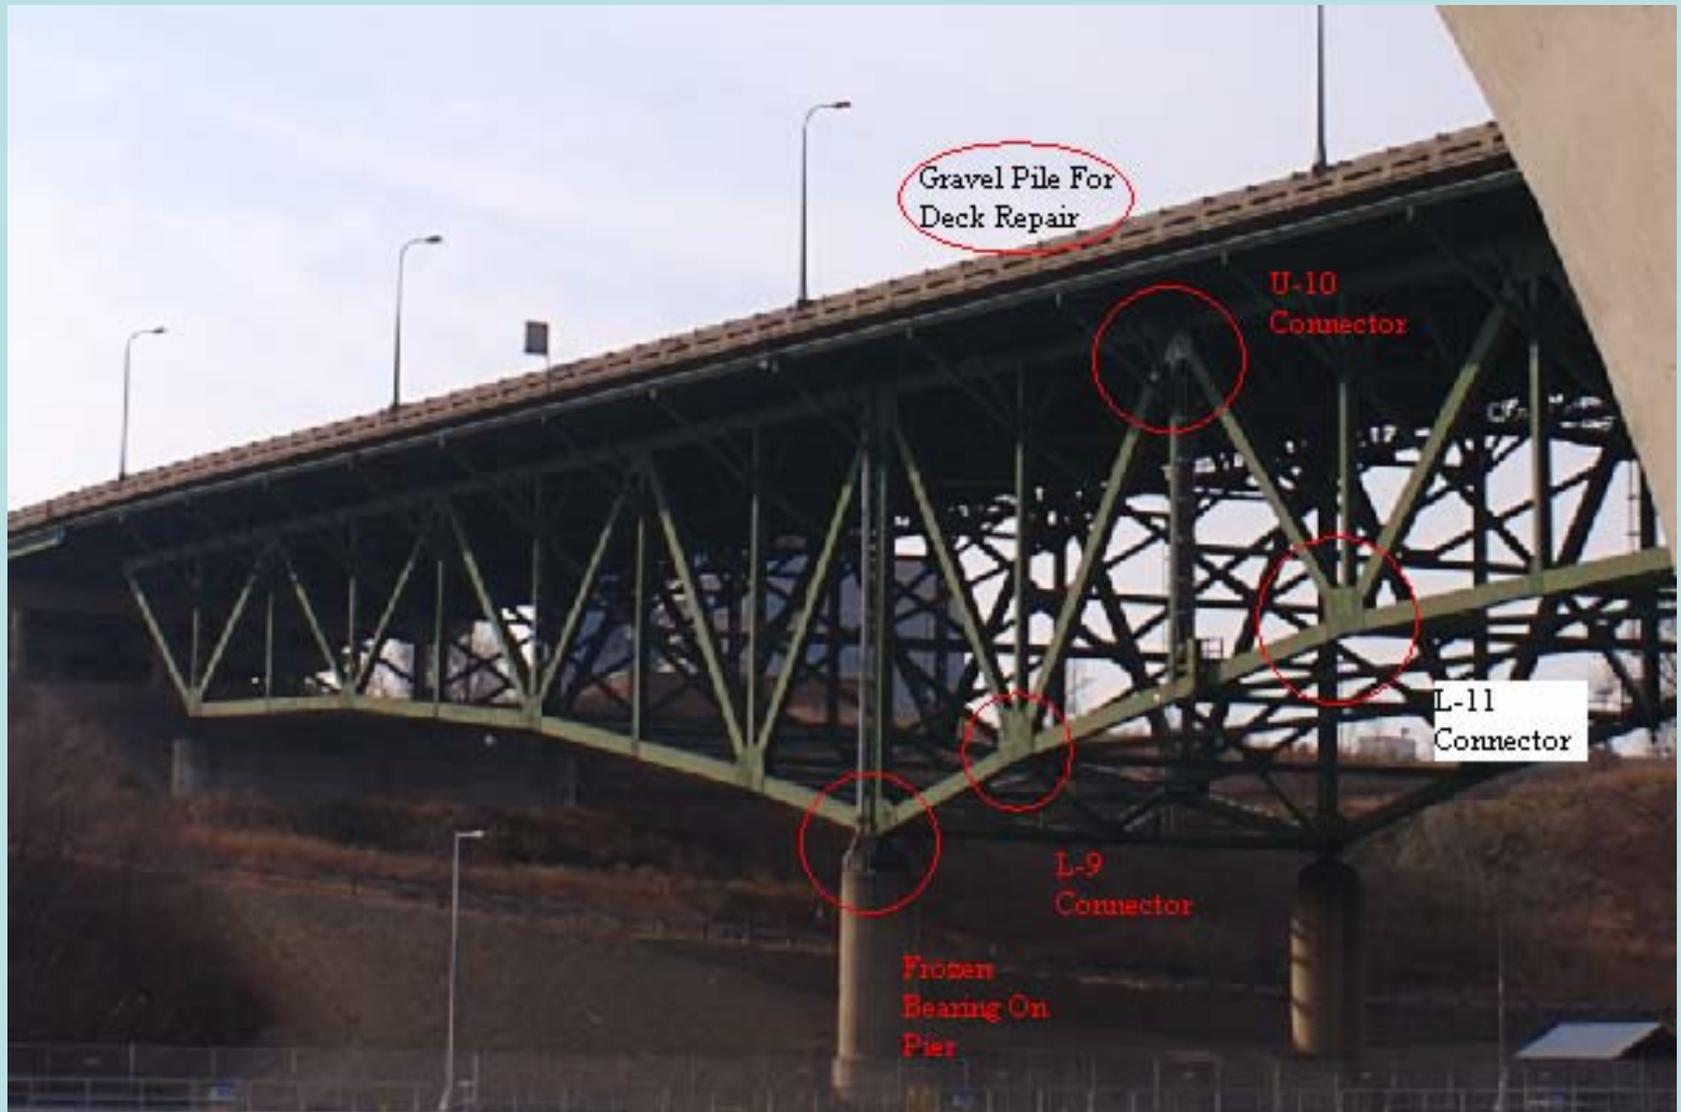
A second unusual factor is that the bridge was undergoing repair work on the deck. The normal 8 lanes were reduced to 2 lanes each direction, with two lanes each direction being closed for repair work. The northbound lanes had a large pile of gravel placed right above the U-9 and U-10 connector joints.

The third leg of the disaster concerns the gusset plates that held the beams together at the connector joints. These plates vary from one-half inch to one inch in thickness. There is speculation that the one-half inch plates may have been too thin to support the weight of the bridge, a design flaw that may have been an accident waiting to happen. In addition, recent inspections have found that rust was attacking these gusset plates. The L-11 gusset plate had lost one-half of its thickness in places due to rust. To aggravate this situation, anti-ice solution and salt may have collected in this area speeding up the corrosion, and bird droppings may have accumulated in this area making inspections all the more difficult.

The Minneapolis Star Tribune reports that connectors L-9, U-10, and L-11 all show evidence of pre-collapse damage. The failure of any one of these gusset plates would start a chain reaction of failures that would lead to the collapse of the bridge.
